Biodeterioration of peridotite and other constructional materials in a building of the Colombian cultural heritage

Abstract

Keywords: Biofilms; Cultural heritage; Veracruz church; Peridotite; Weathering

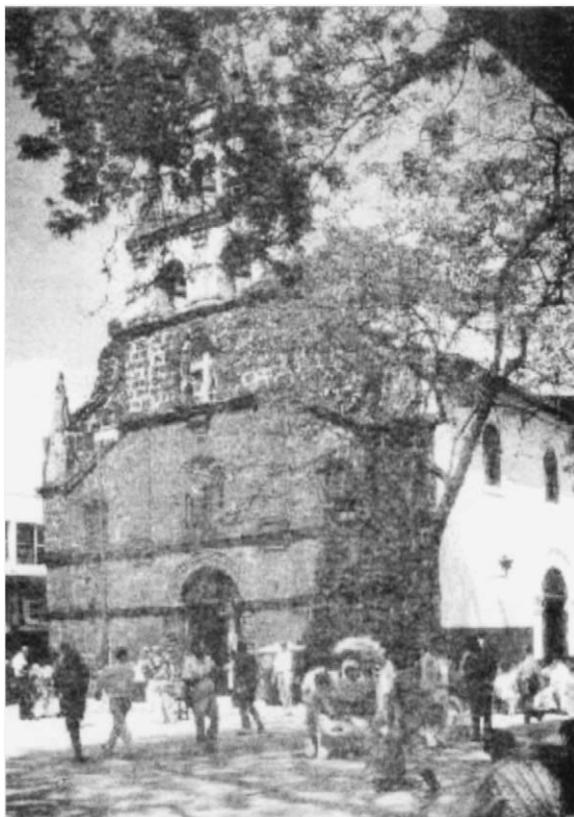
Fig. 1. Church of Veracruz, Medellín, Colombia.

The practical case chosen for this study is the church of Veracruz (Fig. 1), a building typical of the Colombian city of Medellín's cultural heritage. The façade was built with peridotite, a material obtained from quarries north of the valley of Aburra where the city is located. Peridotite is an ultrabasic igneous rock composed of dark minerals (generally olivine and pyroxene) containing iron and magnesium. It can also contain some plagioclase and minerals like chromite and limonite, with some addition of feldspar and quartz. A characteristic of this type of rock is that it can be easily turn in to serpentine due to the instability of olivine in atmospheric conditions (Quintero and Delgado, 1998).

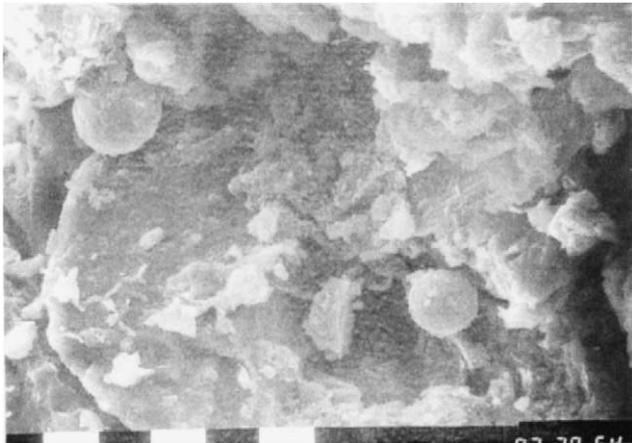
Fig. 2. SEM micrograph of coccoid cyanobacteria within crust removed from façade of church (magnification: $\times 1000$, bar: 10 μm).

Algae and coccoid or filamentous types of cyanobacteria were present in several samples (Fig. 2). Members of the Chlorophyta in the Ulothricales and Chlorococcales and cyanobacteria in the Oscillatoriales and Chroococcales were found in all the samples studied.

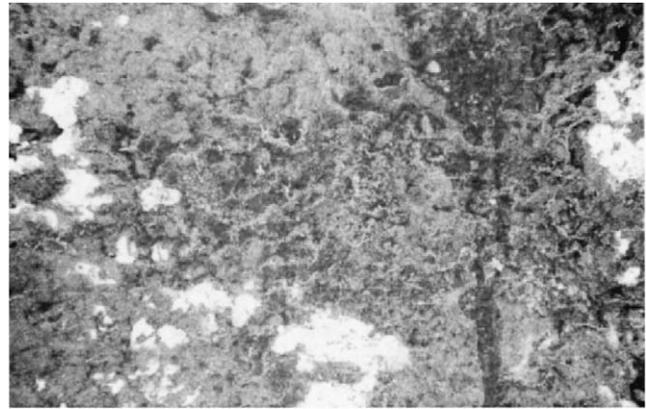
Fig. 3. Dark patina caused by cyanobacteria on peridotite of façade of church.

In the city of Medellín, natural environmental factors and urban pollution (due to deposition and attack of aggressive gases and adhering particles) can lead to the formation of patina and crusts, as was observed on the surface of the peridotite in the façade (Fig. 3). Moreover, the presence of cyanobacteria and algae and their metabolic activity contribute to different accelerating and catalytic effects on the formation of crusts and also to a biogenic colouring of the stone, with a consequent loss of aesthetic value. Dark colored crusts on natural stone of buildings or monuments enhance the physical stress of the structural material by increase in specific heat uptake as well as alteration of thermal-hygric expansion behavior and moisture retaining capacity (Warscheid and Krumbein, 1996). These

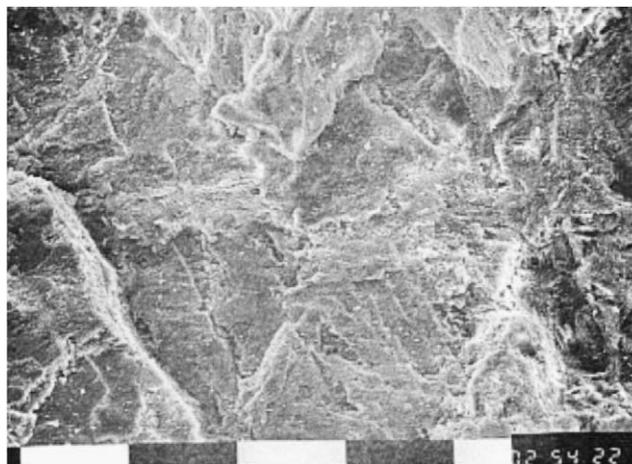
Fig. 4. SEM micrograph of rock from source quarry (magnification: $\times 200$, bar: 100 μm).

A degree of weathering of the peridotite shown up by SEM of the mineral taken from the source quarry and the corresponding material from the church façade (Figs. 4 and 5). The FT-IR analysis of peridotite (Table 4), EDAX profiles (Figs. 6 and 7) and XRD spectra (Fig. 8) indicate that the weathering of peridotite mainly leads to the presence of olivine that is later turned into serpentine and different iron oxides, predominantly lepidocrocite and goethite (Herrera et al., 2003). Petrographic analysis confirmed these observations (Videla et al., 2003).

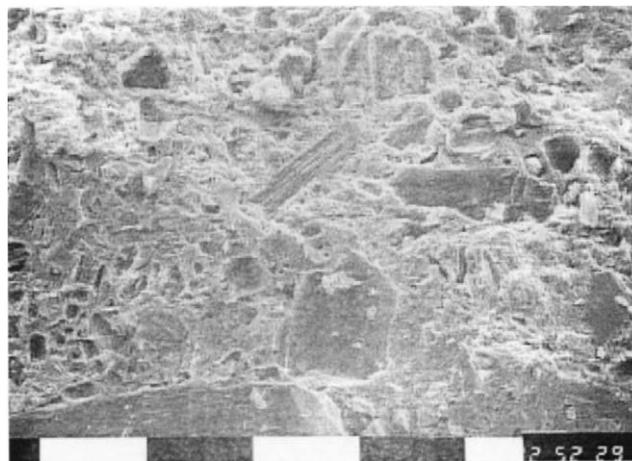
Fig. 5. SEM micrograph of weathered peridotite from façade of church (magnification: $\times 200$, bar: 100 μm).

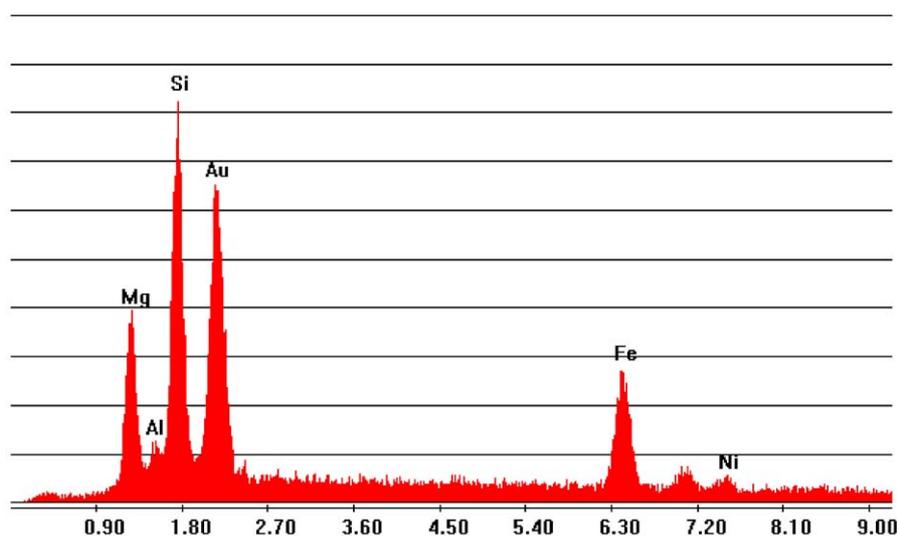
Label A: V11

Fig. 6. EDAX profile of rock from source quarry.

From the comparative EDAX and XRD results, it can be concluded that most of the rock constituents of peridotite are thermodynamically unstable under the environmental conditions to which the church is exposed. However, damage due to weathering effects in an urban atmosphere of only moderate aggressiveness such as that of Medellín would be

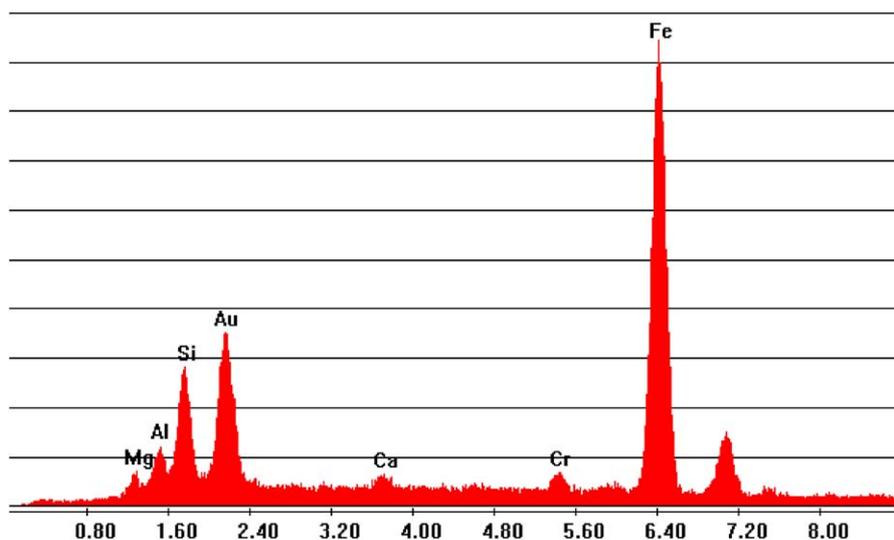
Label A: 25229

Fig. 7. EDAX profile of weathered peridotite from façade of church.

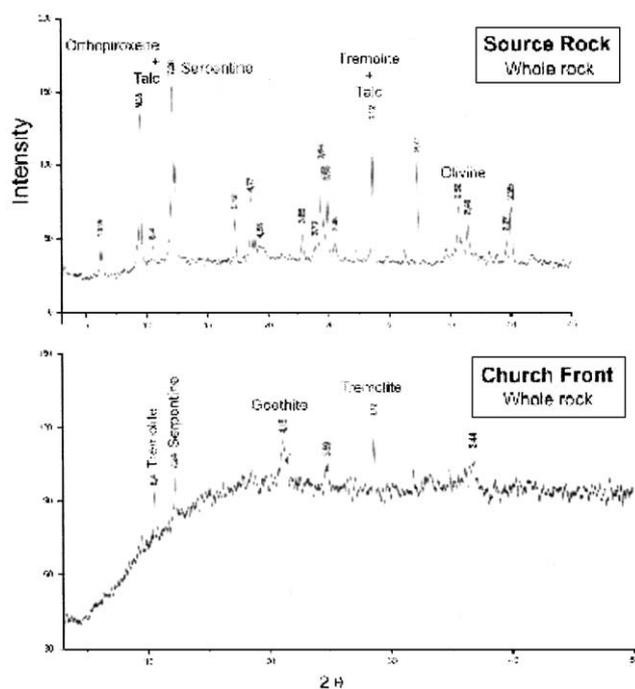
Fig. 8. XRD spectra of source rock and whole weathered rock.
