Case study

## Biofouling of crypts of historical and architectural interest at La Plata Cemetery (Argentina)

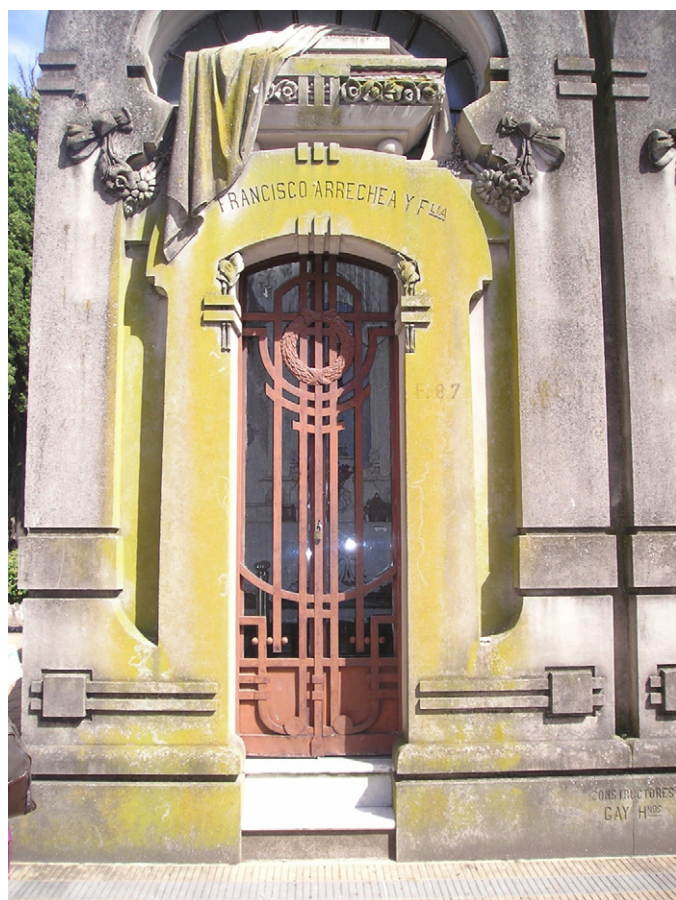
**Fig. 1.** Portico of the crypt of Francisco Arrechea (crypt F87), which is of architectural interest because of its Art Nouveau style. The yellowish coloration is indicative of the presence of *Caloplaca austrocintra*.

- crypt C95 (marble column);
- crypt C77 (inner side of the marble);
- crypt F87 (front, cement mortar – Fig. 1);
- crypt A9 (front, cement mortar);
- crypt A9 (side wall and front).

Lichens identified as *Caloplaca austroclitina* Vondrák, Riha, Arup and Søchting [7], *Xanthoria candelaria* (L.) Th. Fries, *Lecanora albescens* (Hoffm) Branth and Rostr., and *Xanthoparmelia farinosa* were found on cement mortar, especially on crypt F87. Approximately 95% of the affected surface was covered by *Caloplaca austroclitina* and less than 5% by other lichens. Lichens belonging to the *Caloplaca* genus are known to colonize natural stone. Nimis et al. [8], in Latium and Tretiach et al. [9] in Sardinia, identified about 300 different species of lichens on archaeological remains. In that study, almost all *Caloplaca* sp. were found on calcareous rock with a SW, S, E, or SE exposure. The exception was *Caloplaca ochracea*, which occurred on northern exposures, specifically, in shaded sites near the soil. *Caloplaca* was also found to have colonized the carbonate rock (limestone) of the Jeronimos Monastery (Lisbon), where lichen thalli of *Thyrea*, *Aspicilia*, and *Verrucaria* were detected as well [10]. Colonies of *Caloplaca* sp., among others, were also identified on the pavement mosaics of the Romanesque town of Italica (Seville). Direct colonization of the tesserae was shown to have been preceded by colonization of the mortar [11]. Deruelle et al. [12] identified the nitrophiles *Caloplaca citrina*, *Xanthoria candelaria*, and *Lecanora albescens* on the Basilica of Notre-Dame de

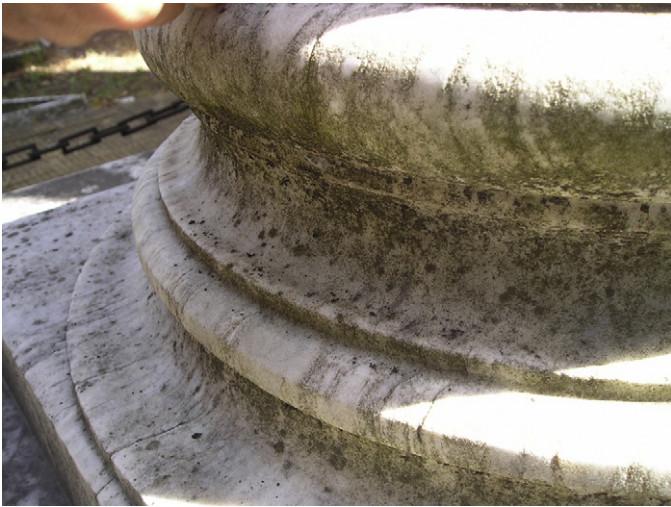
Fig. 2. Biofilm on the marble column of crypt C95.

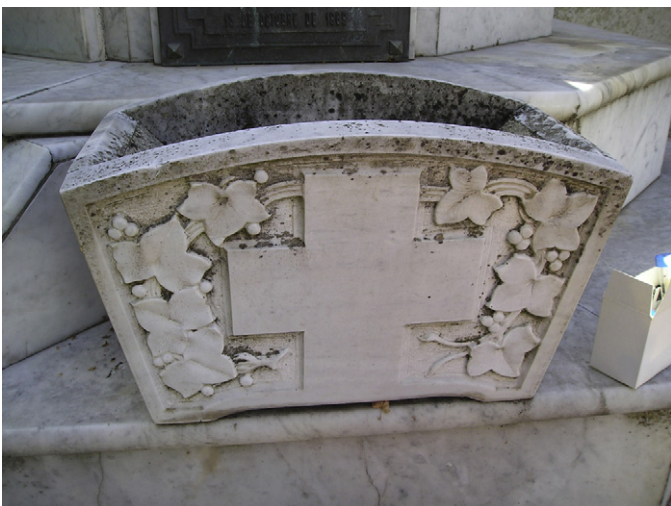
Fig. 3. Dark biofilm on a marble flowerpot across from crypt C77.
