Biodeterioration of funeral sculptures in La Recoleta Cemetery, Buenos Aires, Argentina: Pre- and post-intervention studies

Funeral sculptures

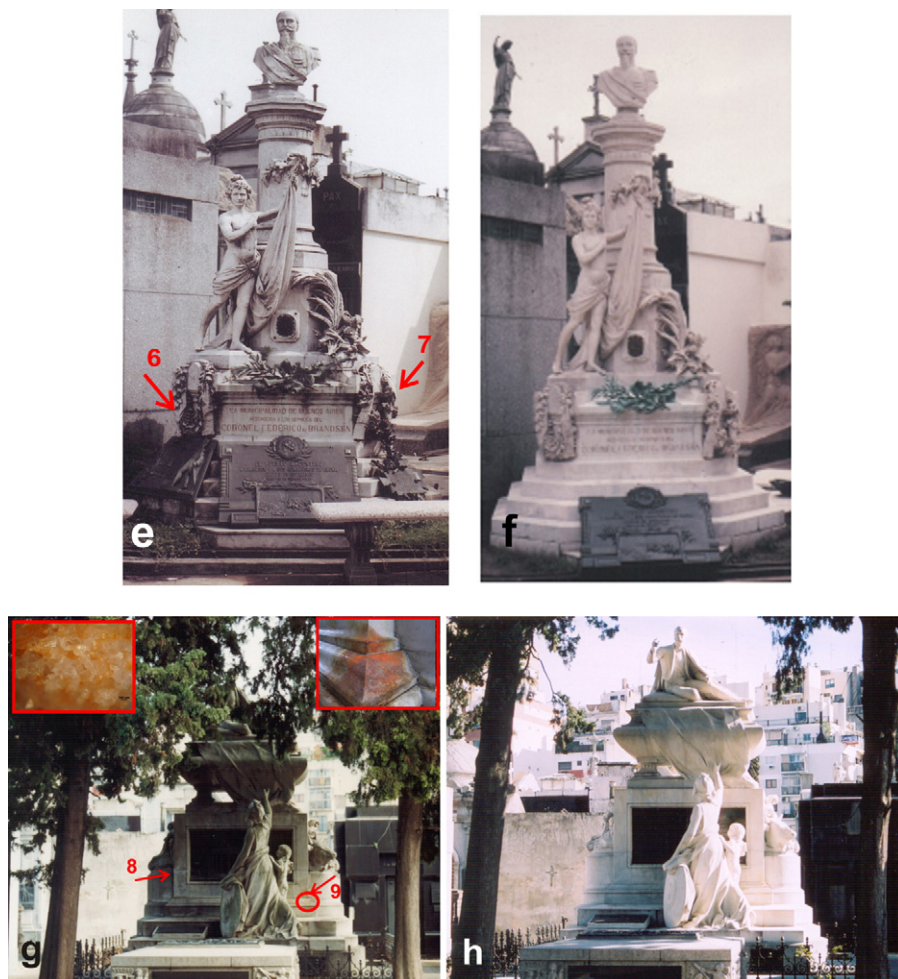
Fig. 1. Pre- and post-intervention of tombstones: José C. Paz (a and b), Rufina Cambaceres (c and d), Carlos Brandsen (e and f) and Carlos Pellegrini (g and h). Details of 1g right side: zone with red stained area; left side: optical microscope image with red carotenoid pigmentation due to algae *Trentepohlia* sp. (10 \times). (For interpretation of the references to color in this figure legend, the reader is referred to the web version of the article.)

Fig. 1. (Continued)

The following samples were taken: two at the José C. Paz memorial (1 and 2), three at that of Rufina Cambaceres (3–5) two at that of Carlos Brandsen (6 and 7) and two at that of Carlos Pellegrini (8 and 9) (Fig. 1a, c, e and g). Samples 1, 7–9 showed discoloration, sample 2 microkarst, samples 1–9 biological colonization, samples 4 and 8 differential erosion, sample 5 peeling and sample 6 soiling [10].

The greatest biomass was found on the Carlos Brandsen and Carlos Pellegrini tombstones, studied in autumn of 2002 and 2006 respectively. Algae of the *Trentepohlia* genus were identified in both tombstones. Similar pigmentation was also detected in a few other monuments. The detail in Fig. 1g (right side) shows the coverage of

surface by *Trentepohlia*. This algal genus has long been recognized as biodeteriogenic on buildings and is well known for its production of pink/brown discoloration [30] caused by biogenic pigments. It has also been associated with mechanical degradation of monuments in Spain [31] and Mexico [28]. Pigment production in these biofilms is an adaptation that increases resistance against environmental stress [32].

In the case of the Rufina Cambaceres tombstone, after intervention (Fig. 1b), fungal hyphae have obviously persisted in the substrate (or have recolonized the marble); it is of great importance to perform such biocide treatments periodically. In the four tombstones that formed this study, José C. Paz, Rufina Cambaceres, Carlos Brandsen and Carlos Pellegrini, the interventions allowed complete interpretations of the monuments to be recovered [39] (Fig. 1b, d, f and h). In the case of Carlos Brandsen and Carlos Pellegrini tombstones, it was of particular interest to detect the origin of small chromatic zones, which remain unchanged in area with the passing of time without changing the image of the monument. Results revealed that algae of the *Trentepohlia* genus were responsible for this discoloration, visible both pre- and post-intervention (Fig. 1g and h).

Detail of Fig. 1g (left side) shows marble discolored by carotenoid pigment released from *Trentepohlia*. This kind of discoloration was detected in samples from Carlos Brandsen and Carlos Pellegrini tombstones.

The red chromatic zones were caused by the alga *Trentepohlia*; they did not increase in size during the post-intervention periods. However, their presence is connected with deterioration and so other biocides or alternatives should be tested.

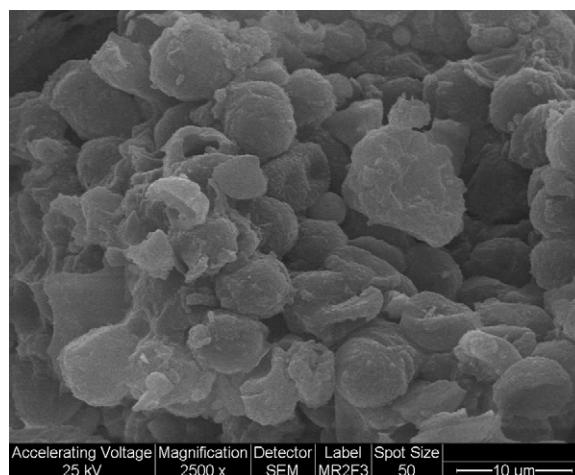
Fig. 3. SEM photomicrograph. Marble of the pre-intervention Rufina Cambaceres tombstone. Fungal microcolonies are observed.

Stone disintegration can be linked to fungal growth. These microorganisms are particularly concentrated on the stone coatings. They are able to penetrate into the material with the grown of hyphae and to cause bioerosion, biosolubilization by organic and inorganic acid excretion (oxalic and fumaric acids) and cationic oxidation of the minerals [3,4,7,33,34] as well as by organic agents that chelate the metallic cations of the stone [35,36]. The abundance of biological material, the EPS and the adherence of a complex microbial community (molds and bacteria) (Fig. 3), may alter the structure and integrity of the stone causing cohesiveness
